1. Project Name: Rota SBH
2. Date of Inspection: June 6, 2002
3. Inspection Personnel:

Revetted Mole - 535 LF:

ROTA HARBOR, NORTHERN MARIANAS

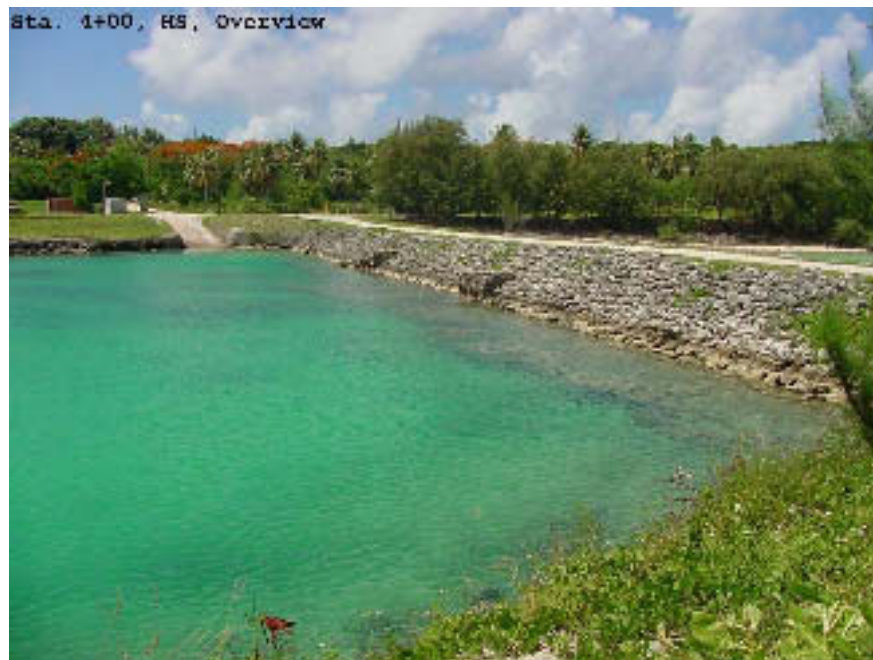
The Revetted mole is approximately 535 LF. The overall condition of the project is fair. There has been some on-going deterioration, at Sta. 1+80, (1st. Set of Culverts) which has progressed to a point where repairs are required to ensure the continuing functionality of the structure.
